TMU-O
TEKNISKT MEDDELANDE ULTRALÄTTA FLYGPLAN
OBLIGATORISKA ÅTGÄRDER

TMU-O 57

TITEL: Kontroll av trimroder för höjdrodret.

GÄLLER: Skylane IV och Skylane V5

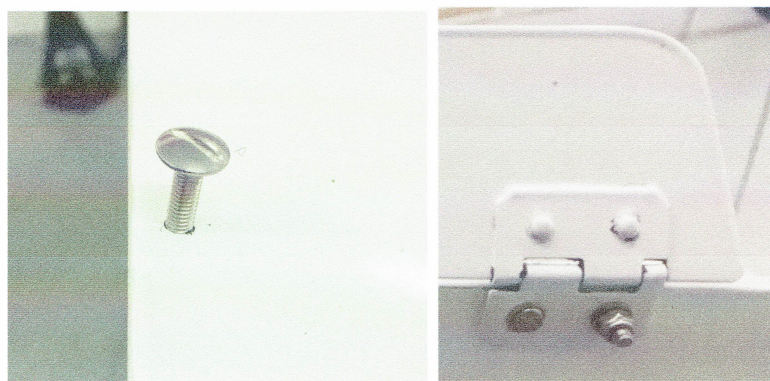
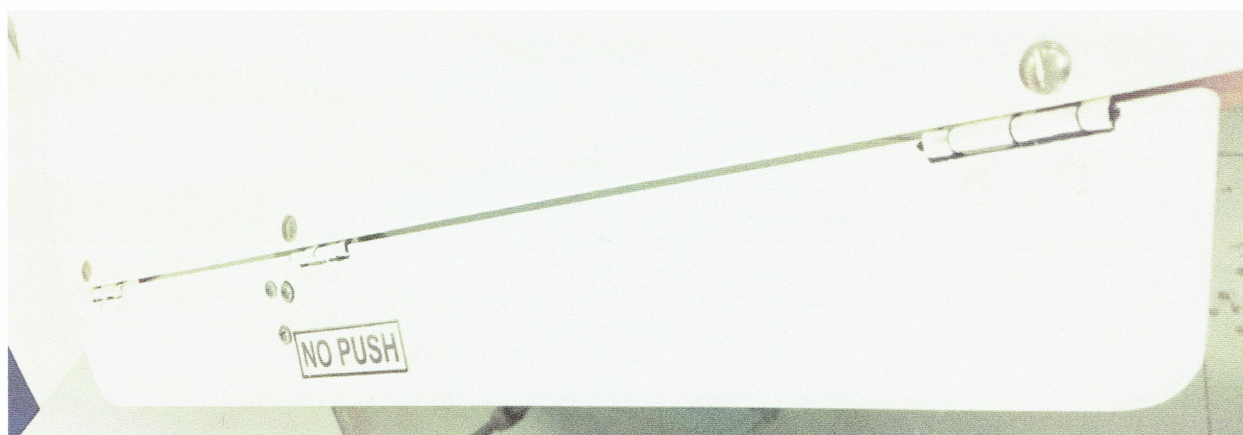
ORSAK: Skruvarna som är av typen korta plåtskruv som skruvas in i kompositmaterialet och håller gångjärnet till trimrodret vid höjdrodret har visat sig kunna lossna. Hela trimrodret kan i värsta fall lossna och enbart hänga i trimrodervajern och orsaka roderfladder.

The trim rudder is fastened with 6 screws (2 screws on each hinge) into the underside of the elevator's trailing edge.

If one experience problems with the screws not staying in place and thus not holding the trim rudder hinges in place, then the alternative fastening method below is a possible solution:

Drill a 3,2 mm hole through the elevator's trailing edge in one of the holes on each of the three hinges.

Replace the screw in that hole (one for each hinge) with an M3 screw with big head and locking nut (see pictures).

Add a bit of epoxy in the remaining holes before replacing the other three screws.
